Independent Hybrid Corrosion Protection Appraisal

On behalf of:
Concrete Preservation Technologies Ltd.

DuoGuard™ Hybrid Anode™ Site Performance Review

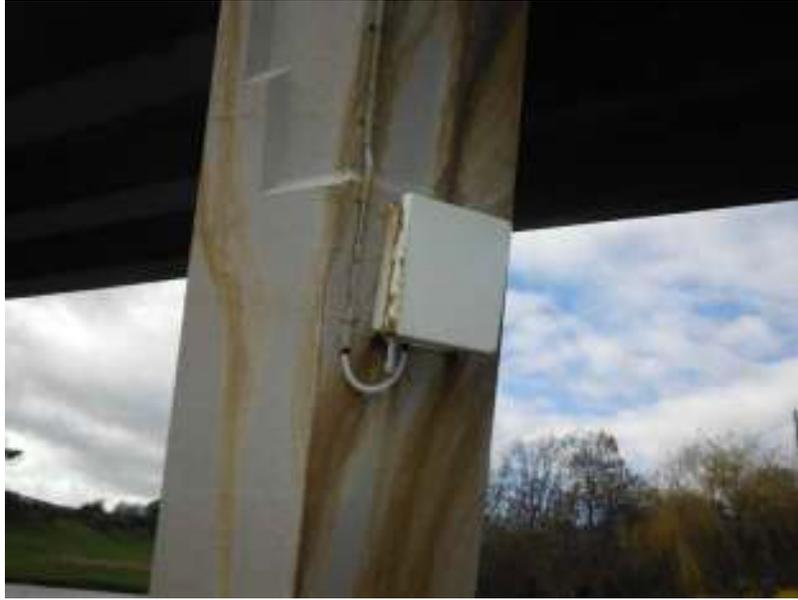
Figure 10 - Data logging equipment

It was observed that the run-off from the waterproof coating is causing some deterioration to the IP65 GRP monitoring box which houses the data logging equipment (Figure 10). It is believed that rust staining may be from deterioration of the galvanised steel fixings that were used in the installation. This could lead to potential damage of the monitoring equipment preventing remote depolarisation readings to be taken. No areas of delamination were identified during the inspection.

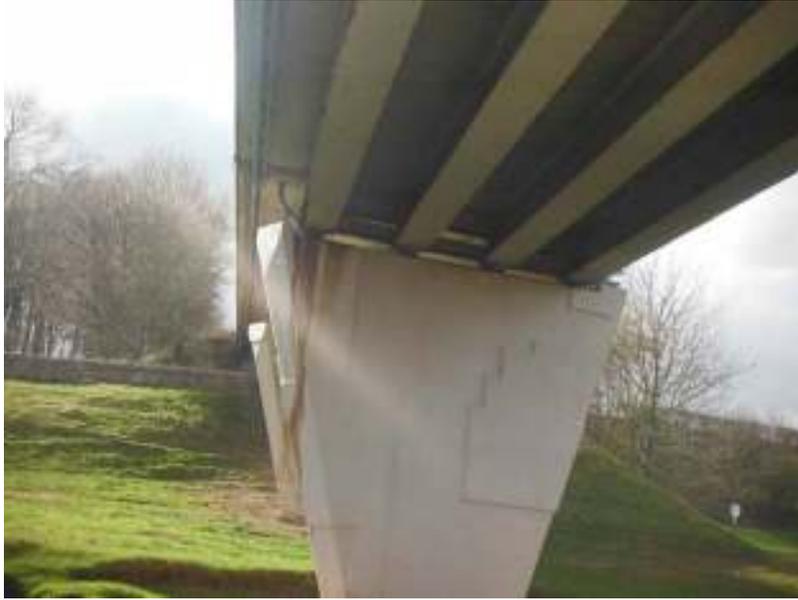
Figure 11 - Water and rust staining from steel girders

The reinforced concrete piers were found to be in generally good condition but with some water ingress defects observed. A significant amount of water and rust staining was noted on the piers however it is believed that this arises from the primary steel girders when water ingress occurs through the deck joints or through a fault in the drainage system. The extent of water and rust staining at high levels of the reinforced concrete piers can be seen in Figure 11. On closer inspection, evidence of corrosion of the steel girders was observed near to the location of all bridge joints suggesting that they are now failing to prevent water and chloride ingress from the above carriageway (Figure 12). The ingress of water and possible chlorides to the reinforced concrete will be significantly reduced by the applied waterproof coating on the piers.

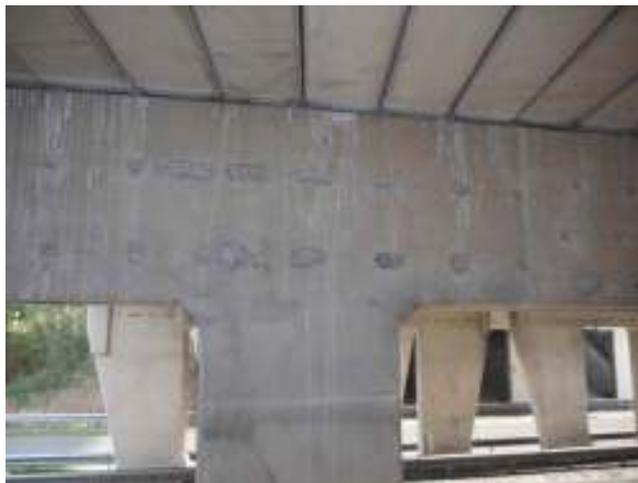
Figure 16 - Water staining on reinforced concrete pier

A visual inspection of the reinforced concrete piers was conducted from ground level on 18th March 2014. The waterproof surface coating made it difficult to effectively conduct a hammer tap survey to identify surface cracking or delaminated areas of concrete; however, no visible defects were noted. The reinforced concrete piers were found to be in generally good condition with only minor defects observed. Water staining was observed at high level in the reinforced concrete piers which suggests that bridge joints are leaking from the above carriageway (Figure 16).

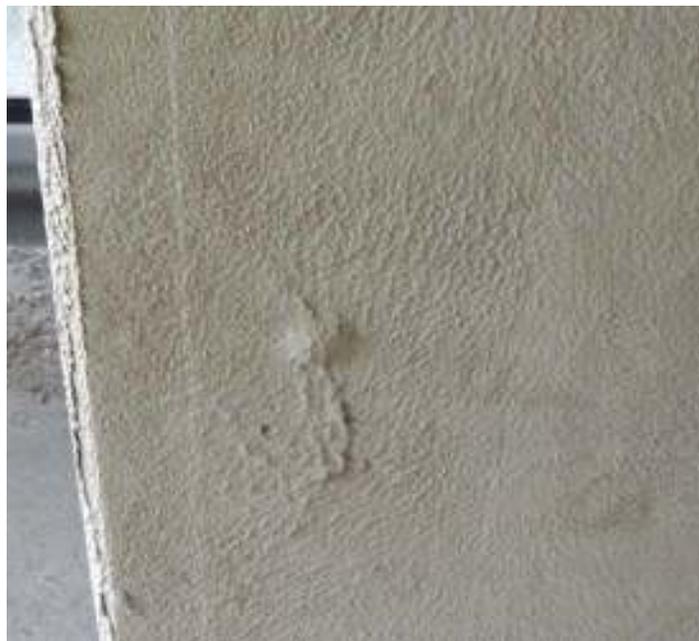
Figure 18 - Surface coating defect

The enclosure for the data logging equipment was found to be in good condition (Figure 17). Minor cracking was observed in the waterproof coating in a number of locations; however the depth of the crack could not be confirmed. Only one defect which was outside the area of influence of the hybrid CP system was identified during the hammer tap survey covering an area of approximately 1000 x 400mm. It is a possibility that the defect may be due to a debonding of the waterproof coating as other minor surface coating defects were also observed during the inspection (Figure 18). Alternatively it may be due to delamination of the concrete surface as there is a small possibility that the adjacent anode zone has been disconnected.

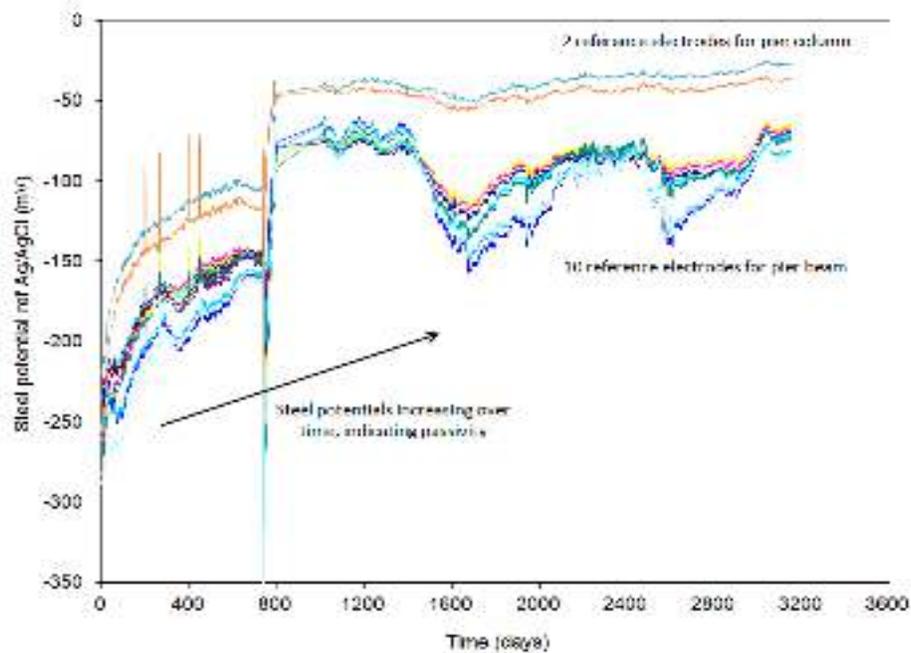
Figure 19 - Steel potential shift with time, Laverock Hall Bridge

CPT Ltd have continued to record long term monitoring data, taking an 'on potential' and current reading at daily intervals from 28th July 2006 to 10th March 2015. Figure 19 shows how the steel potentials have continued to shift towards more passive conditions over time. This data combined with the recorded depolarisation readings and the visual inspection suggests a low corrosion risk for this structure.

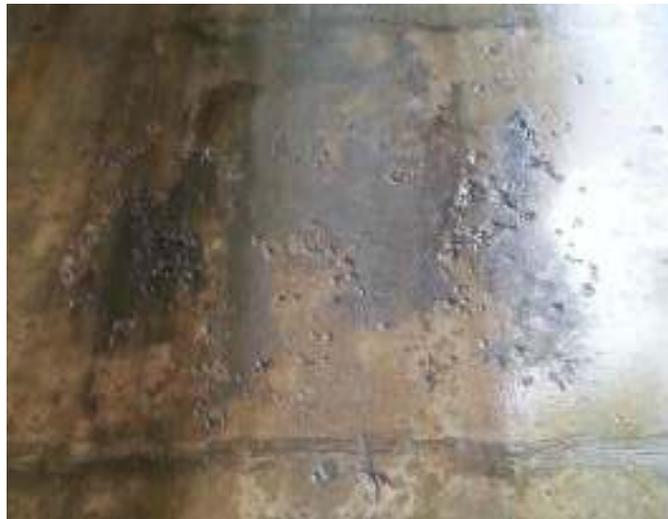
Figure 24 - Honeycombing and surface delamination to South abutment

Large areas of surface delamination and honeycombing were observed along the South abutment (2-3mm deep) as seen in Figure 24. These areas are located at low levels of the abutment well away from the hybrid treated section, in conjunction with areas of water ingress from the leaking bridge joints and also within the spray zone from the adjacent single carriageway. A significant amount of cracks were also observed on both abutments and ranged from 1m to 2.5m in length and were 1 to 2mm in width. The cracks are located at similar locations on both abutments which suggest that the cracks may be due to drying shrinkage of the concrete rather than corrosion damage. Figure 25 shows cracking to the North abutment.

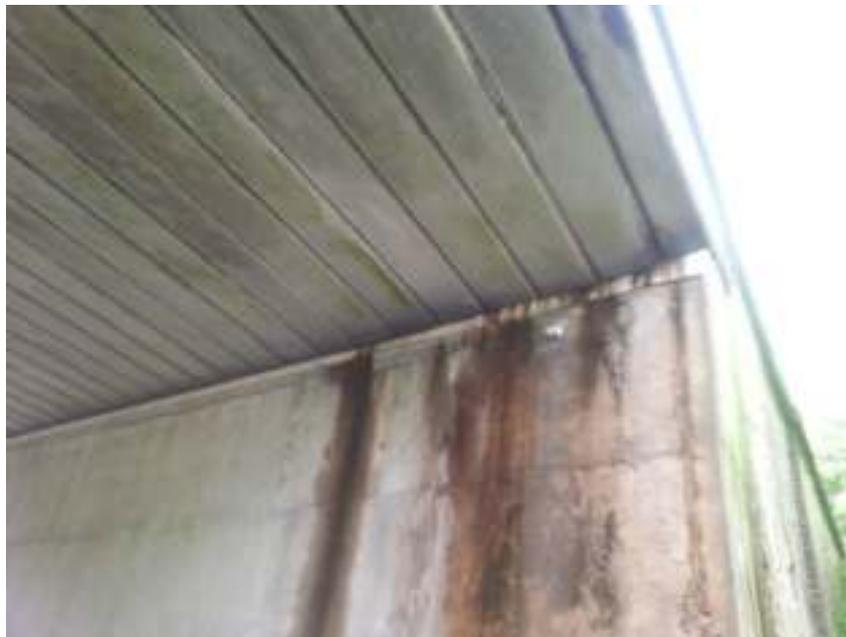
Figure 26 - Rust and water staining from bridge joint on South abutment

Rust and water staining from the bridge joint was observed at the South West corner of the South abutment (Figure 26). As the visual inspection was only conducted from ground level the source of the rust staining could not be confirmed. The area surrounding the hybrid anode installation showed no signs of corrosion induced deterioration.

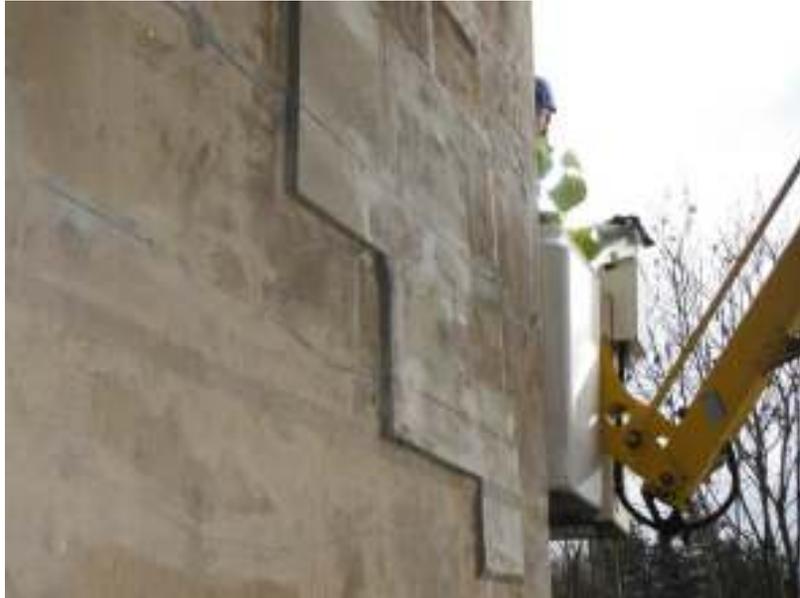
Figure 32 - Low cover areas reinstated to an adequate depth

A visual inspection of the structure was conducted from ground level and covered both the traffic and verge faces of all four piers. Overall, there were little or no signs of corrosion found and only a small number of defects were visible. The areas of steel reinforcement, originally identified with a low concrete cover, were re-constructed to provide an adequate cover depth (Figure 32). During the inspection a superficial defect was identified adjacent to a patch repair.

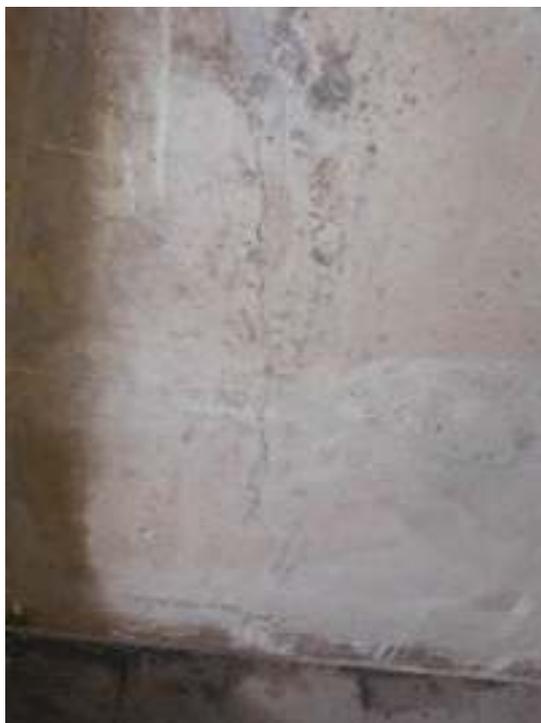
Figure 33 - Longitudinal cracking

A number of longitudinal cracks outside the zone of influence of the hybrid CP system, approximately 1-2mm wide, were observed in the lower section of the piers. It was noted that these cracks were not specified as part of the repair works as a potential mapping survey indicated little risk of corrosion (Figure 33). It was evident from the visual inspection that the majority of bridge joints were in a poor condition (Figure 34) which is causing a significant amount of water ingress from the carriageway above (Figure 35). It is assumed that this water could contain chlorides from de-icing salts which could significantly increase the risk of chloride-induced corrosion.

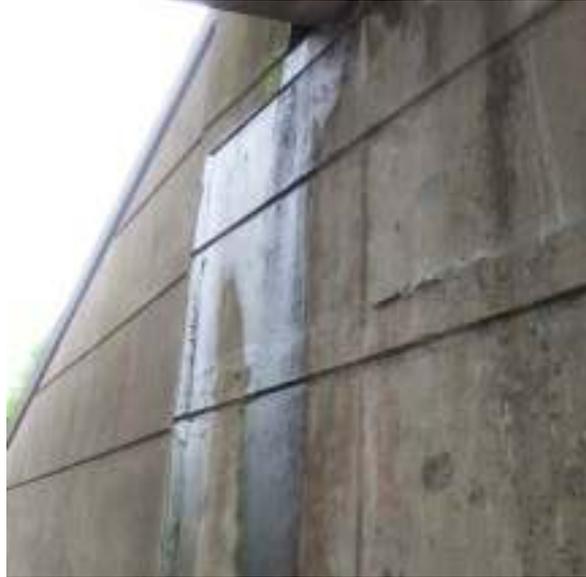
Figure 41 - Water ingress on Huncote Bridge abutment (East side)

A visual inspection of the structure was conducted from ground level on 23rd May 2014 and covered the three abutments with the hybrid anode system installed. There were little or no signs of corrosion found and only a small number of defects were visible. The abutment at Huncote Bridge only showed minor signs of water ingress to the East side from the above carriageway probably as a result of degradation of the expansion joints (Figure 41).

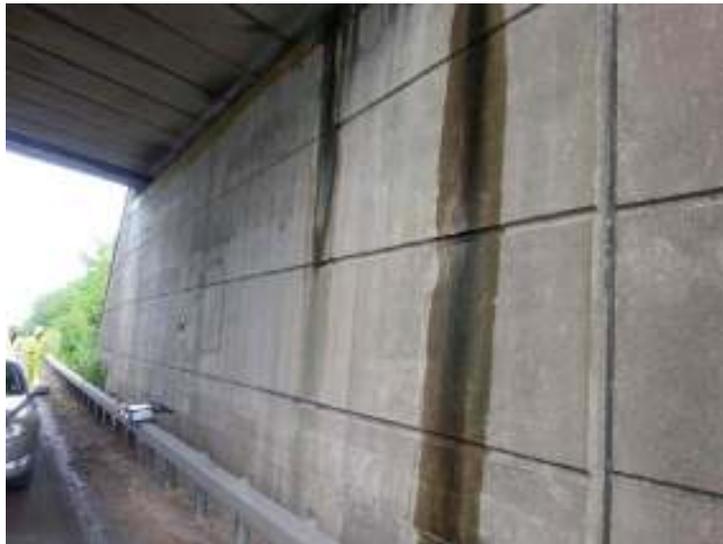
Figure 42 - Water ingress at Junction 2 abutment

The two abutments at Junction 2 of the M69 motorway exhibited a similar extent of water ingress and staining (Figure 42). This again was more prominent at the top of the abutments which suggests water ingress through failing bridge joints from the above carriageway. Surface defects (honeycombing) and localised hairline cracking recorded at lower levels away from the hybrid anode installation (Figure 43). It is unclear whether these cracks have occurred since the hybrid anode installation or whether these areas were missed as part of the concrete repair works in 2012. The cracks ranged from 500mm to 1.2m in length and were only observed in two locations across both abutments at Junction 2. The crack widths were not measured.
