The Parker Street building is a six floor steel framed structure in the centre of Liverpool. The building was suffering from cracking and displacement of the brickwork cladding to the steel frame. In addition leakage through the degraded waterproofing and drainage had led to water damage. The upper section of the roof was refurbished and individual steel I beams suffering corrosion damage were replaced.

Location
Liverpool, UK

Client
Colliers

Structure
Steel Frame Building

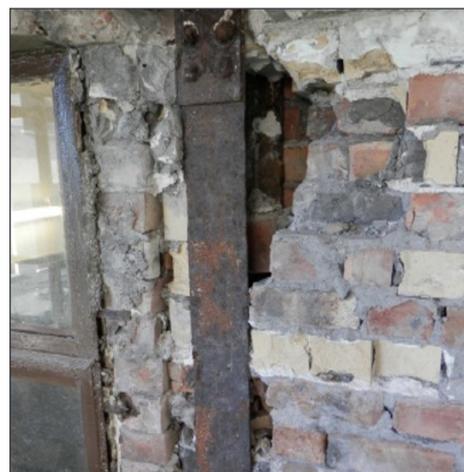
The rear brickwork face of the building was exhibiting cracks and some bulging. Exposure of the steel frame indicated corrosion in numerous sections had occurred, leading to formation of expansive corrosion products which in turn was applying disruptive pressure to the brickwork.

Corrosion found on the rear brickwork face of the building

In order to stop ongoing corrosion and prevent further damage at the Parker Street Building CPT designed a DuoGuard™ hybrid anode system. Initially the bulging brickwork was removed to expose some of the steel I beams. DuoGuard anodes were then installed into the mortar surrounding the beams to deliver a protective current to the steel. Using an external power source, an impressed current was applied to stop active corrosion and render the steel passive. The DuoGuard anodes were then disconnected from the power source to self-generate a galvanic current, sufficient to maintain steel passivity and control corrosion.
