Berkeley Hotel

Client
Maybourne Hotel Group

Structure
Roof Top Swimming Pool

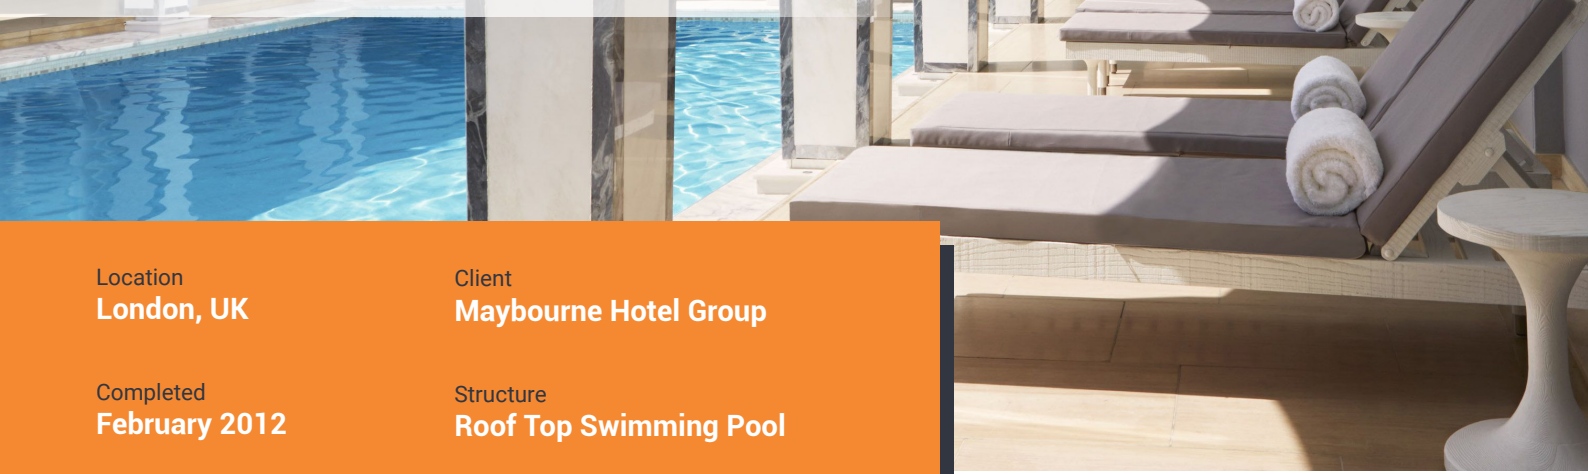
Visual observation showed water leakage from the Berkeley Hotel swimming pool onto the concrete substructure and significant corrosion damage due to chloride attack.

CPT was asked to develop a solution to the corrosion problems on the underside of the pool. A DuoGuard™ hybrid anode system was designed to satisfy the clients insistence on noise restriction which necessitated limited concrete break-out. To halt ongoing corrosion and prevent future damage anodes were installed into the beams of the substructure.

Using an external power source, an impressed current was applied to stop active corrosion and render the steel passive. The DuoGuard anodes were then disconnected from the power source to self-generate a galvanic current, sufficient to maintain steel passivity and control corrosion.

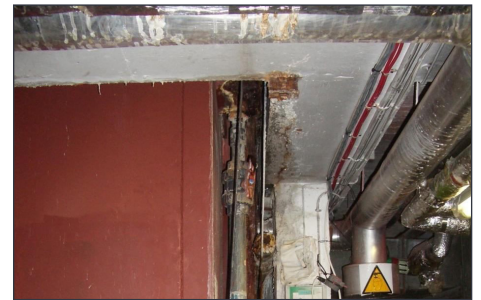
Chloride corrosion to the underside of the pool
