## Case Study

# Grosvenor MSCP

Location  
**Northampton, UK**

Structure  
**Multistorey Car Park**

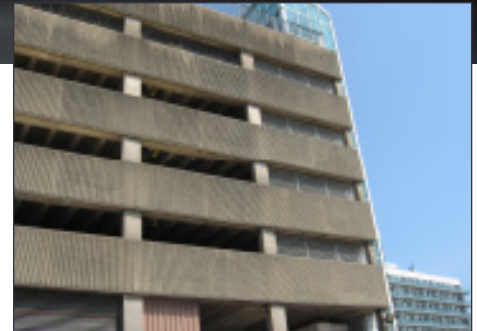
Grosvenor MSCP Car Park

Dynamic cracking and moisture ingress through Grosvenor car park deck joints had led to chloride contamination of the concrete and subsequent reinforcement corrosion. The early failure of previous concrete repairs represented poor value for money for owners as further expenditure was required on the structure.

CPT designed a refurbishment scheme using PatchGuard™ galvanic anodes to stop ongoing corrosion and prevent further failure. Rather than the traditional approach of embedding sacrificial anodes within the patch repair over 1400 PatchGuard anodes were installed in the surrounding concrete. The protective current was delivered directly to the steel outside the patch which was at the greatest corrosion risk, as opposed to the clean steel within the patch repair. Unlike some other galvanic patch repair anodes, high quality polymer modified repair mortar could be used without compromising the cathodic protection provided by the PatchGuard anodes.

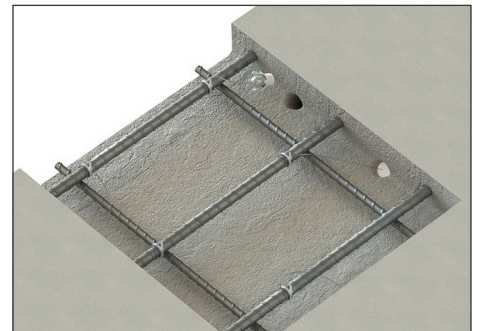
PatchGuard™ Solution
