Whiteadder Bridge

Location Berwick, UK	Client Northumberland County Council
Completed April 2007	Structure Single Carriageway Bridge Over Estuary

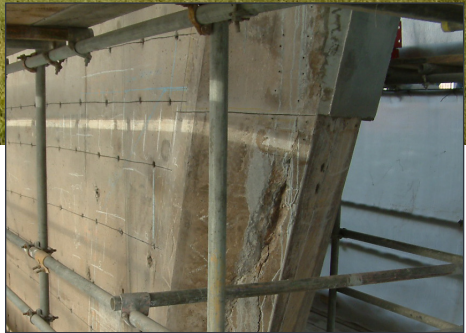
Substantial areas of spalling/loose concrete were visible along with salt deposits in certain areas. In addition to the main substructure, specific areas of the underside of the bridge deck had had been contaminated with significant levels of chloride salts.

Visible spalling and loose concrete

CPT designed a DuoGuard™ 500 hybrid anode system to halt ongoing corrosion and prevent further damage to the contaminated piers and abutments. Using an external power source, an impressed current was applied to stop active corrosion and render the steel passive. The anodes were then disconnected from the power source to self-generate a galvanic current, sufficient to maintain steel passivity and control corrosion.

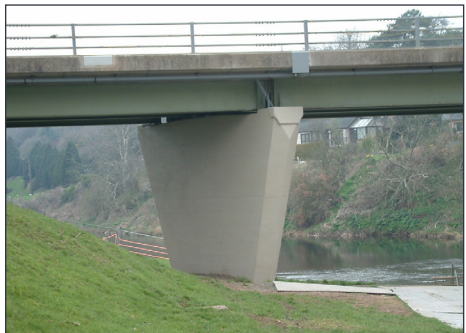
Finished pier 10 years after installation

Corrosion related deterioration of Whiteadder Bridge has been halted. After the initial power up period using an external power source the DuoGuard system is self-powered thus minimising future maintenance requirements and associated life costs.
