Case Study

Lilley Bottom Bridge

Structure
Three span reinforced concrete bridge

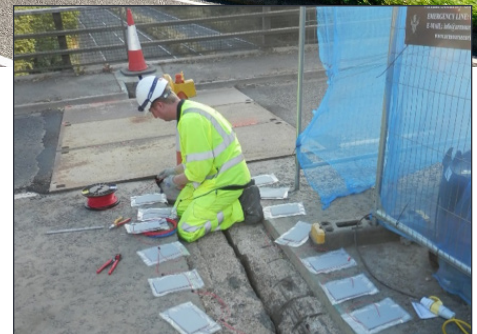
Onsite installation of ProtectorJoint™

As the expansion joints were due to be replaced the opportunity was taken to install the ProtectorJoint™ system inside the joint cavity whilst access was available.

The ProtectorJoint™ anodes were pre-connected and installed at 400mm centres. The anode features a galvanic plate on one face and a compressed foam pad on the back which, when released, presses the anode onto the concrete surface and holds it securely as the joint expands and contracts. The anode material will sacrificially corrode in preference to the surrounding steel reinforcement.

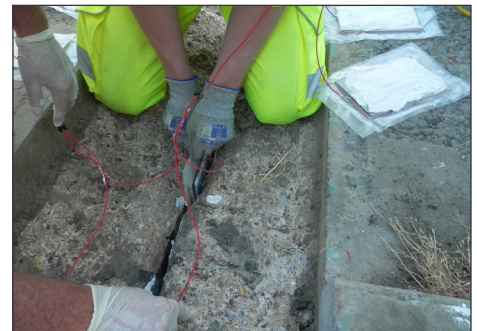
ProtectorJoint™ Solution

The string of anodes was connected to the steel reinforcement via a surface mounted connection box, located at the side of the bridge, where measurements can be taken to monitor system performance.
