Greyhound Bridge

Originally a railway viaduct, Greyhound Bridge was unusually converted for vehicle use by the addition of a concrete deck in 1972.

Structure
200m long road bridge over the River Lune

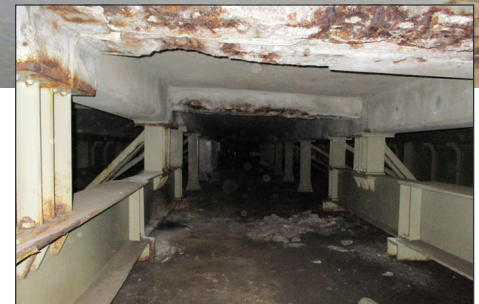
The bridge joints had deteriorated leading to water ingress and chloride induced corrosion of the congested steel reinforcement within the transverse beams of the superstructure. As corrosion is expansive in nature, this resulted in significant cracking and spalling of the concrete cover.

Spalling transverse beams to soffit under deck joints

Hydro-demolition was used to remove the chloride contaminated concrete from around the joints. The concrete was re-cast incorporating RebaGuard galvanic anodes, which were fixed directly to the steel reinforcement, and new joints were installed. Should any water breach the new joints and soak the adjacent concrete, the sacrificial RebaGuard anodes will corrode preferentially and prevent rebar corrosion initiation. RebaGuard anodes with a high zinc mass were selected to reflect the high steel density and provide long term protection to the joint section.

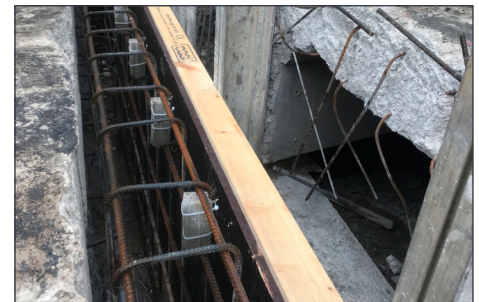
RebaGuard anodes in position ahead of concrete pour
