Portbury Railway Abutment M5 J19-18

Portbury Bridge, a single span reinforced concrete structure, was constructed in 1973 and carries the M5 over a railway line, just south of Bristol.

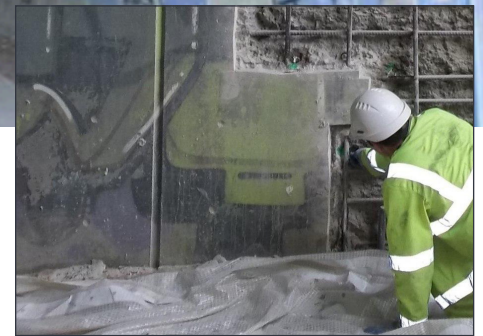
Type 1b anodes being installed to abutment repair

The most cost-effective option was deemed to be the installation of galvanic anodes to patch repairs. Highways England's new standard specification for galvanic anodes, clause 5712 in Volume 1 of the Specification for Highway Works was included in the contract documentation. PatchGuard anodes, described as Type 1b in the specification, are designed to corrode sacrificially for up to 20 years, making the steel reinforcement relatively cathodic and preventing corrosion initiation within the zone of influence of the anodes – typically up to 500mm away from each anode.

PatchGuard anodes are compact and quick to install causing minimum disruption. The anodes are grouted into holes drilled from inside the repair boundary so that the anodes are located in the host concrete, not the repair material. This significantly enhances current output and maximises the level of protection to the steel around the patch. The system is self-powered minimising future maintenance requirements and associated life costs. The risk of secondary corrosion around the perimeter of the concrete patch repairs has been mitigated thus significantly extending the life of the repairs.

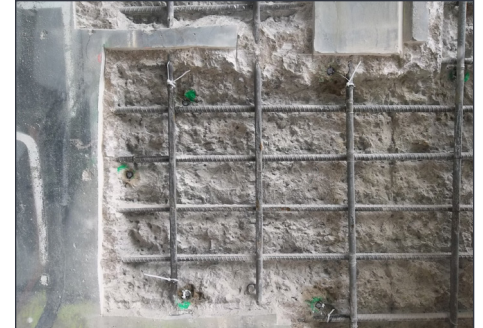
Anodes to perimeter of repair
