Case studies of hybrid and galvanic systems on bridge structures

Abstract. Corrosion of steel in bridge structures is a growing issue worldwide. Case studies of galvanic and hybrid systems show the diverse range of challenges and corrosion hazards that are faced during the design of these systems. Data from these case studies show the effectiveness of this approach. Hybrid systems have been utilised in controlling corrosion during refurbishment work on bridges for over a decade. Galvanic systems have been around much longer. By utilising these systems individually or together there is great flexibility in design. This allows intensive concrete restoration from a hybrid system alongside the maintenance of repairs in lower risk areas from galvanic anodes. This paper presents case studies covering hybrid and galvanic systems applied to bridge structures. Included is a prestressed concrete bridge in a tidal environment, we believe to be the first of its kind fitted with a hybrid system. Tidal considerations and flooding are key challenges in corrosion mitigation. Data shows the systems are particularly effective in these transitory environments reacting rapidly to increased risk.

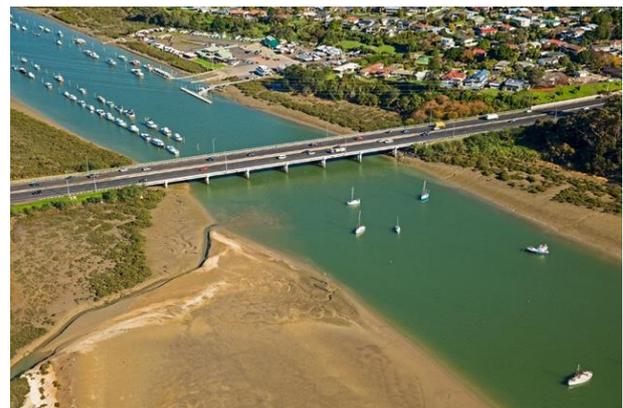
Fig. 1. Aerial view of the existing Whau River Bridge, looking south-west (Corbett & Watterson, 2016 [6])

A 182m long, eight-span bridge bringing traffic across the Whau River. Constructed in stages from the 1950s through to the 1990s, connecting Auckland to the city's western outskirts. The bridge is part of the SH16 which carries an average of 90,000 vehicles per day through an environmentally sensitive coastal reserve [7].

The superstructure consists of reinforced concrete supports with cast reinforced deck beams and deck slabs.

The substructure varies across the bridge, the result of many expansions and alterations.

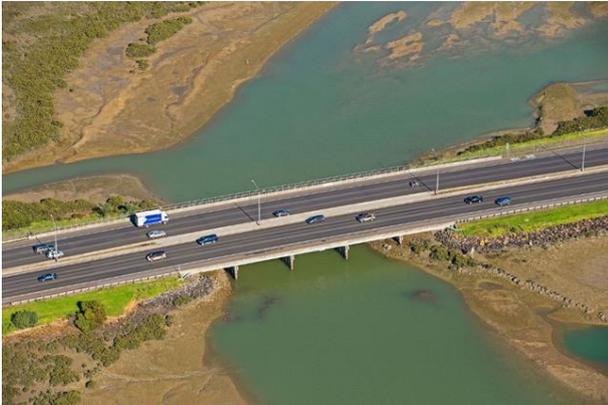
Fig. 2. Aerial view of the existing Causeway Bridge, looking south-west (Corbett & Watterson, 2016 [6])

A 75m long, five-span bridge that brings SH16 traffic over the Oakley inlet waterway close to the Whau River bridge. Originally constructed in the 1950s this structure, like the Whau River bridge, has undergone widening and other alterations into the 1990s. This structure includes pre-tensioned concrete piles from both the 1960s structures and 1990s widening [7].

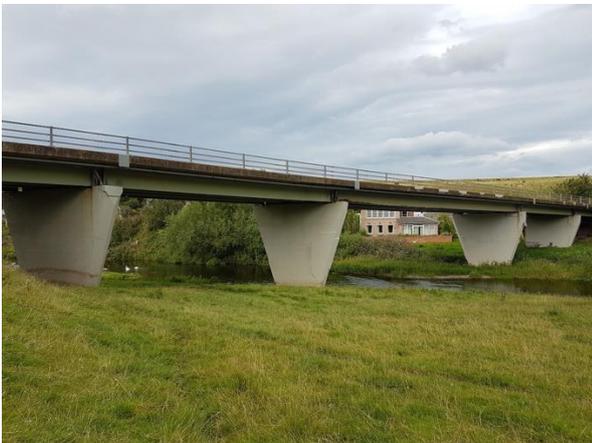
Fig. 3. Whiteadder bridge, Northumberland, taken 10 years after installation

A 90m single carriageway bridge structure constructed from steel girders supported on bearings directly above 4 trapezoidal reinforced concrete piers, the deck is constructed from reinforced concrete beams spanning horizontally between the four primary steel girders. The unique shape of the piers leads to steel density increasing towards to bottom. Built in 1973, it carries motor traffic over a tributary flowing into the river tweed which is prone to flooding [8].

Whiteadder bridge showed substantial spalling and delamination on the piers from what appeared to be chloride ingress caused by leaking deck joints. Salt deposits were visible on the surface in some areas. The high concentration of chlorides was confirmed through testing a variety of locations by drilling in sections to the depth of the steel and collecting dust for analysis. The highest chloride ion content was found in two locations on a pier on the west side of the river. It measured 1.68% chloride by weight of cement, a high risk of chloride-induced corrosion. The half-cell potential map confirmed the high risk of corrosion and gave information that would allow the targeting of known, local anodic areas within the structure.

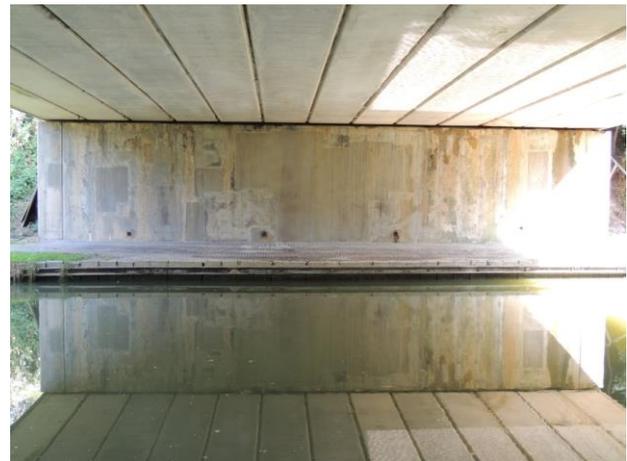
Fig. 4. Abutment shown from opposing bank 4 years after patch repairs

A 1970s 14m bridge carrying traffic via a dual carriageway over the canal in central Milton Keynes. Reinforced abutments support the concrete deck that spans the waterway. Leaking bridge joints resulted in contamination and corrosion in the abutments.

Visual inspection of the H6 canal bridge showed visible signs of chloride induced pitting on the exposed steel and the source of chloride appeared, from staining patterns, to be a leaking bridge joint allowing salt from the road above to be carried down through seepage. Through chemical analysis, it became clear that chloride was the instigator of the corrosion. Being by a canal the environment was very humid leading to widespread corrosion. The 2D potential map showed large anodic areas in need of protection.

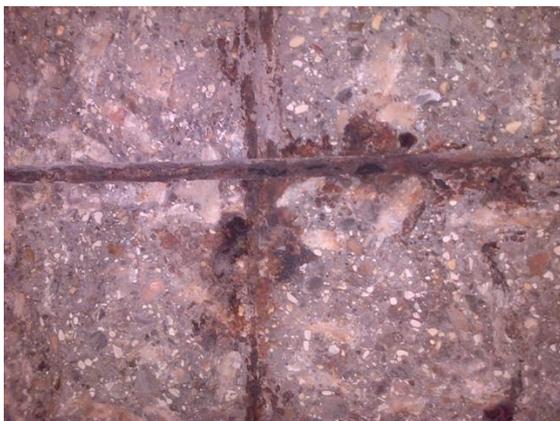
Fig. 5. Chloride pitting on the steel broken out during the repair of H6 canal bridge

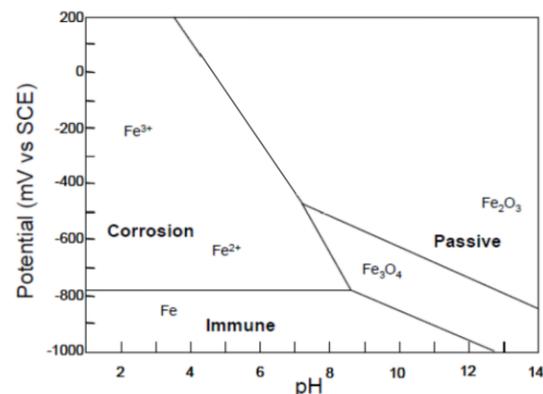
Fig. 6. Simplified Pourbaix diagram of iron

Steel is not just protected by its polarisation; new concrete has a naturally high pH which protects the steel from corrosion. Carbonation and chloride ions decrease the pH environment of the steel making the steel vulnerable to anodic corrosion. An effective way of managing corrosion is to restore and maintain the concrete around the steel. The cathodic steel uses electrons to create an alkaline hydroxide environment. These ions restore the pH of the concrete. Once the pH gets high enough the steel will passivate, and corrosion will be managed. [14]

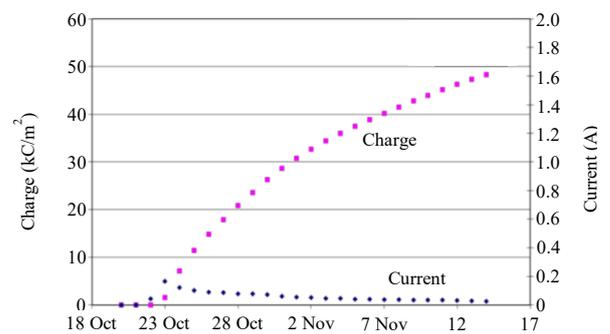
Following installation, the hybrid systems were connected to the power source and energised to deliver the 50kC/m² of charge to the steel reinforcement. Data showing the polarisation of the reinforcement up to 50kC/m² of steel surface area and the current applied to a single zone are shown below:

Fig. 7. Typical charge density and current applied to a zone [7]

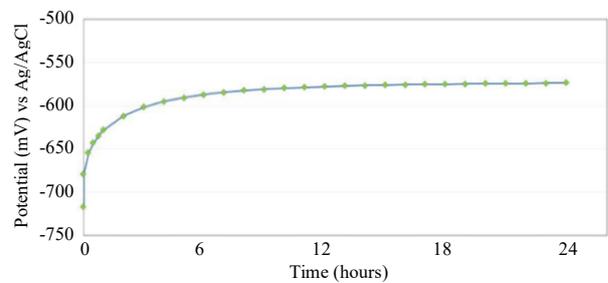
After completing the impressed current phase, the system is tested using a depolarisation test as stated in the ISO 12696:2016 standard. Below is shown the depolarisation test data for atmospheric and splash zones:

Fig. 8. Depolarisation taken in an atmospheric zone [7]

It can be seen that a depolarisation greater than 100mV over 24hrs has been achieved for the both zones. The steel is therefore seen to have sufficient cathodic protection. In

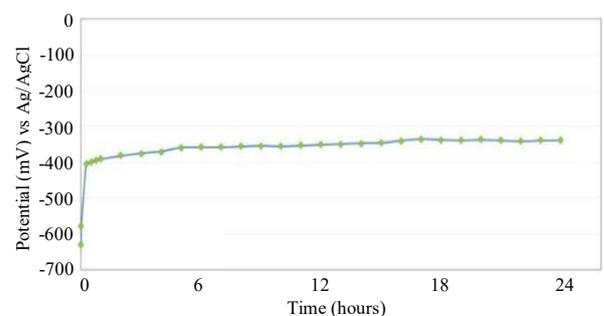
Fig. 9. Depolarisation taken in a splash zone [7]

the splash zone, a greater polarisation potential of 240mV is measured over 24hrs. In these zones, the steel has been passivated during the impressed current phase and the steel is completely protected by the anodes.

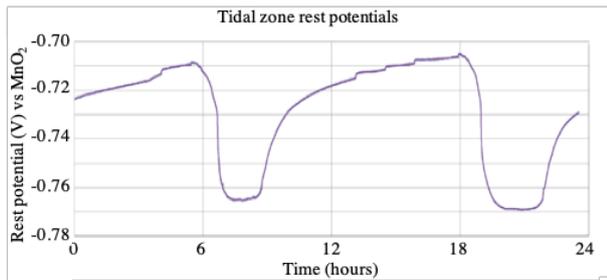
Fig. 7. Rest potentials in a tidal zone [7]

As shown above, the drop seen in potential during low and high tide is 40-65mV over approximately 9 hours across the piers. This changing environment will limit the ability to do standard depolarisation tests. Instead, calculated corrosion rates for the areas will be used.

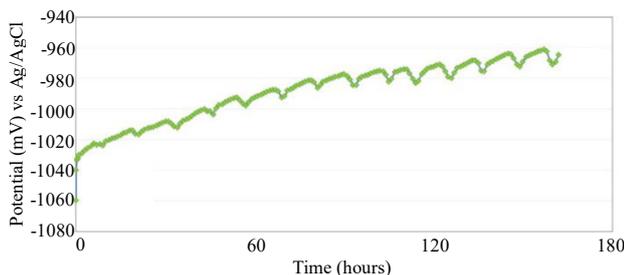
Fig. 8. Depolarisation of a tidal zone over 160 hours [7]

Given the measured corrosion rates fall below the threshold for corrosion risk and clearly rising steel potentials in the tidal zones, protection can be said to have been achieved.

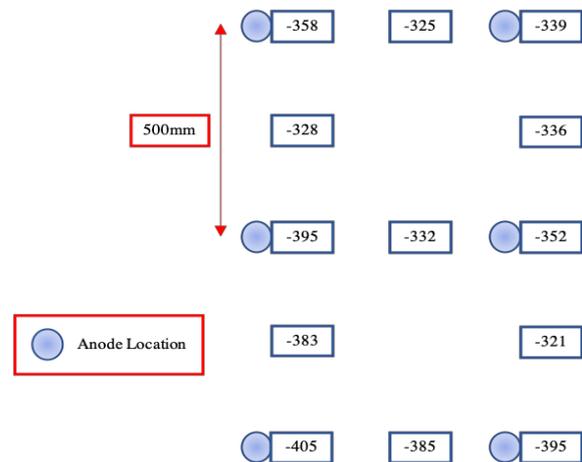
Fig. 9. Half-cell potential data from Test Area 1 (in mV v CSE)

It can be seen that the galvanic anodes can be clearly identified by measuring surface half-cell potentials i.e. the most anodic areas are associated with the installed galvanic anodes – this confirms that the anodes continue to generate current and are polarising the steel such that this can be measured on site. This also confirms that the steel has the least negative potential and as it is relatively cathodic and being protected by the sacrificial anodes.

When potential measurements are taken with respect to the reinforcement, a large negative potential indicates an anodic area. Therefore, when potential maps are taken, the most negative areas should be the sacrificial galvanic anodes that were embedded. Areas of negative potential away from the anodes will point towards possible corroding anodic steel, these areas will be likely exposed to increased chloride or moisture levels.

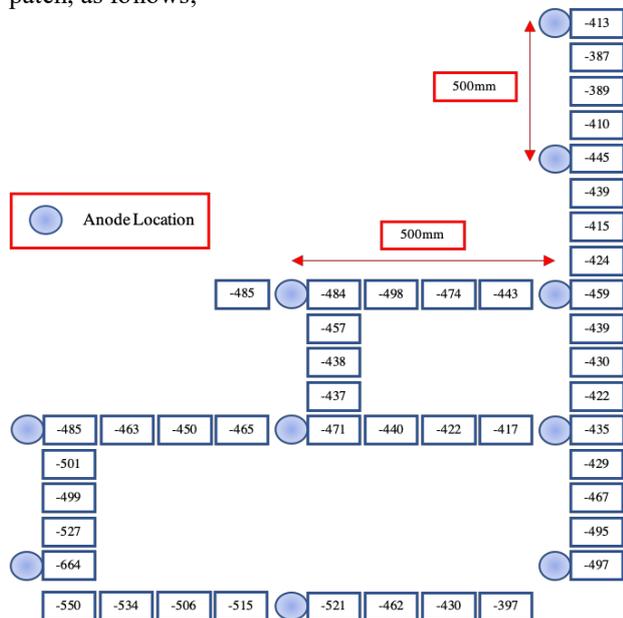
Fig. 11. Half-cell potential map from Test Area 3 (in mV v CSE)

Data from test area 3 was obtained from the bottom of the bridge structure adjacent to the large patch repair and shows that the anodes again can be identified from surface half-cell potential measurements. In addition, one of the anodes at the base of the structure is at a very negative potential (-664mV) indicating greater activity in an area where moisture levels are higher. It is clear that potentials generally get more negative on moving towards the bottom of the structure where there is more moisture and sacrificial anode activity is higher. This demonstrates the responsive behaviour of sacrificial anodes which generate current when the moisture content, and therefore the tendency for higher corrosion risk increases. The anode systems are functioning well to control corrosion and respond to moisture levels from both the canal and salt-laden water from the bridge above.

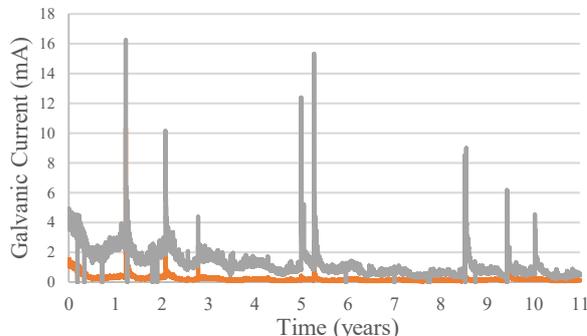
Fig. 12. Galvanic currents in upper and lower zones of Whiteadder bridge over 11 years

This is the most recent data for Whiteadder. Large peaks, an order of magnitude greater than the steady-state, can be seen at irregular intervals over the 11 years of data. These peaks are reactions to the river flooding with the rise mainly seen in the lower zone. The system is working well to protect the steel increasing the current reactively during a period of high risk until the moisture levels and resistivity drop back to normal.

The initial current generated by the anodes after the end of the impressed current phase is quite high because of the moisture in the embedding mortar. The current then reduces as the mortar dries until it reaches a steady, low, maintenance current, this steady state current represents

the work done to maintain the system once the local concrete environment is restored. Like the bridges in New Zealand, there is a clear difference between the 'wet' lower and 'dry' upper zones. A larger current is drawn in the 'wet' zone due to the lower resistivity of the concrete which protects against the increased risk from the moisture.

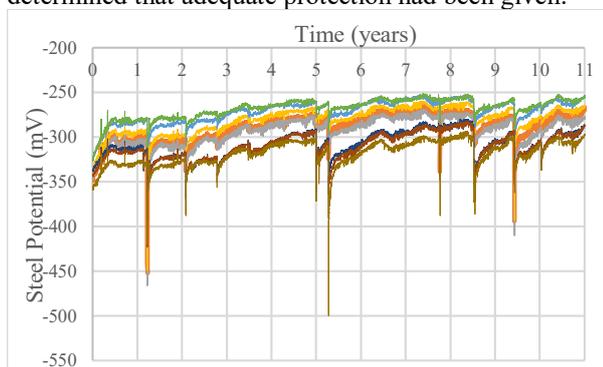
Further proof of adequate protection is given by the migration of the steel potentials towards more positive values, a sign of the steel passivity. The dips correspond to the same flooding events seen before which caused responsive behaviour from the anodes. Given that after 8 years the corrosion rate was calculated at 1.60mA/m^2 coupled with the rising potential of the steel, it was determined that adequate protection had been given.

Fig. 13. Steel potentials data over 11 years [4]

There is a strong correlation between the anode current and steel potential values. As the potentials tend more positive the anodic current tends towards lower values as the demand is reduced by the benign environment of the steel. During the flooding events, near instantaneous reactions are observed to both the anodic current and the steel potential, showing that even after many years the galvanic system remains active and responds to higher corrosion risk by preferentially corroding and polarising the steel.

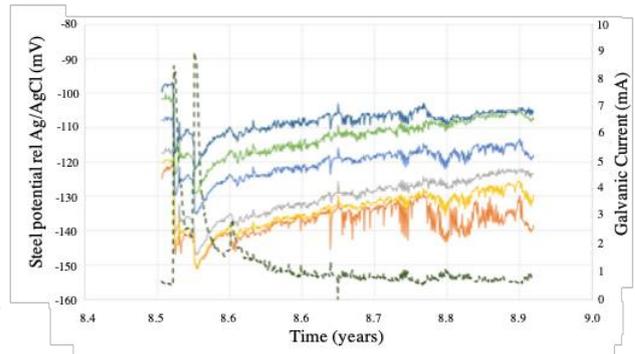
Fig. 14. Response of steel potential and galvanic current to a flooding event [4]

The responsive behaviour of galvanic anodes makes them uniquely suited to the transitory environments found on bridges or other river and marine structures worldwide. Whether the water source be from humidity, a canal, flooding, rainfall, or salinated from salt laden water

seeping through leaking joints, galvanic anodes respond to the corrosion risk to protect the steel reinforcement.

This reactive, self-regulating system therefore only provides high currents in response to corrosion hazards increasing the lifetime of the system. Whiteadder bridge was designed for a 30-year lifetime and was guaranteed for 20 years but is currently on track to have a usable lifetime in excess of 50 years [4, 8]
