# Lulworth House

Lulworth House is a 19 storey, 56m tall tower block on the Agar Grove Estate in Camden, North West London. Completed circa 1964, the structure was designed as two conjoined, offset rectangular blocks and completed with flat roofs. The structure occupies a prominent position within the Agar estate and is the only high rise within the development.

Structure  
**Lulworth House  
(Residential Building)**

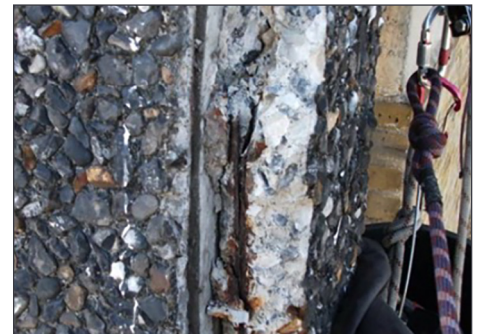
In 2011 spalling of the pre-cast panels occurred, concrete debris fell from the building and a protective scaffolding was rapidly installed around the structure to safeguard residents.

A survey was undertaken which found that pre-cast panels beneath the windows and edges of Lulworth House contained cast in chlorides in quantities known to initiate reinforcement corrosion. As a consequence of high levels of chlorides any future repairs were likely to fail prematurely due to corrosion activity around the patch, induced through the removal of contaminated concrete i.e. the 'incipient anode' or 'ring anode' effect. The Concrete Consultancy 2000 Ltd. provided Camden Council with a detailed report that recommended the use of PatchGuard™ galvanic anodes.

Spalling found on the pre-cast panels

The PatchGuard anodes were installed in the repaired panels in the surrounding concrete, rather than the traditional approach of embedding sacrificial anodes within the patch repair. The protective current was delivered directly to the steel outside the patch which was at the greatest corrosion risk, as opposed to the clean steel within the patch repair.
