Woodhouse Close

Woodhouse Close Leisure Complex is located in Durham. Built in 1968 the complex comprises two swimming pools, a gym, sauna and steam room.

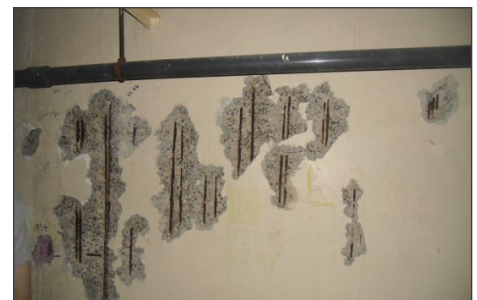
In 2013, CPT carried out an assessment of the two swimming pools. The testing, which included carbonation depth analysis, chloride profiling and half-cell potential surveys showed that the pool walls and walkway soffits were suffering from a combination of chloride and carbonation induced corrosion.

Corrosion found on the pool walls and walkway soffits

Based on the results of the testing, in 2014, CPT designed a bespoke DuoGuard™ hybrid anode solution to halt ongoing corrosion and to treat the areas at the highest risk of further corrosion damage. This involved the installation of over 1650 anodes divided into 40 individual anode zones spread across the pool undercroft. (below ground level rooms alongside swimming pool tanks housing filtration services etc.)

Using an external power source, an impressed current was applied to stop active corrosion and render the steel passive. The DuoGuard anodes were then disconnected from the power source to self-generate a galvanic current, sufficient to maintain steel passivity and control corrosion. All individual zones could be accessed and re-powered should conditions change in the future.
