The Performance and Assessment of Galvanic Anodes In Concrete Structures

C. Stone, G. Glass and D. Bewley, Concrete Preservation Technologies Ltd.

Introduction

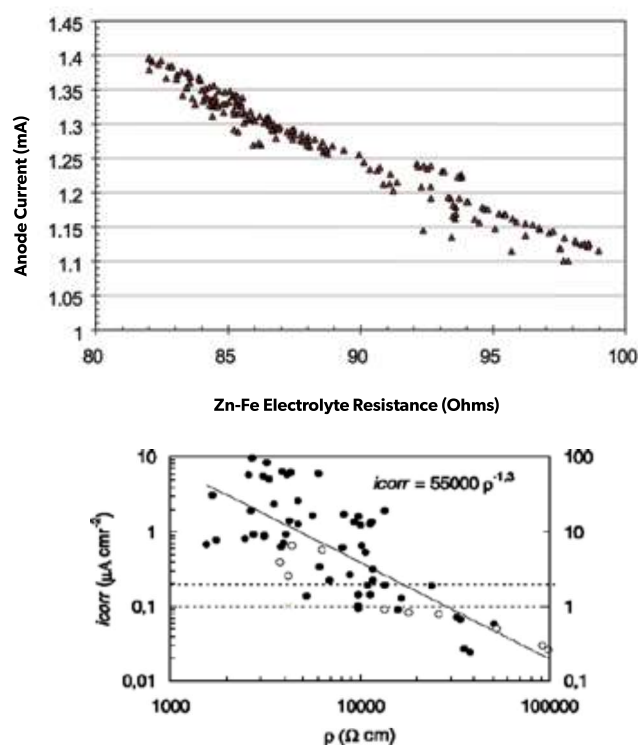
Figure 1: Effect of Resistivity on Anode Current Output [3] and Steel Corrosion Rate [4].

Early methods of galvanic anode assessment involved the use of potential mapping to evaluate the zone of influence of an anode, that is, the distribution of beneficial effects [2]. In 2004, the responsive nature of galvanic anodes was noted (see figure 1). Galvanic anode protection current was shown to respond to changes in environmental resistivity, just as reinforcement corrosion responds to changes in resistivity [3]. More galvanic current was delivered during times of higher corrosion risk.

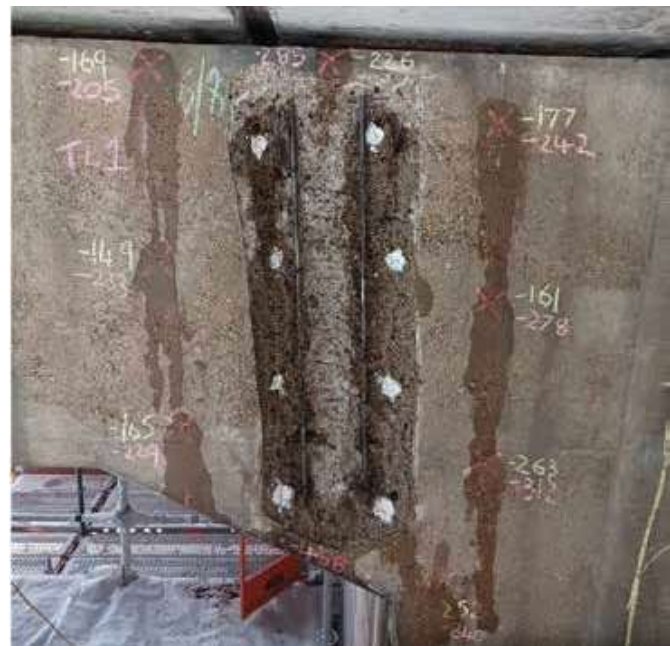
Figure 3: Steel Potentials were Recorded Before (Yellow) and After (Pink) Connection of The Galvanic Anodes.

An example of before and after steel potentials recorded around a patch repair to a National Highways structure in 2023 is provided in Figure 3.

Potential measurements may be used as a form of commissioning. The data can show that the anodes are connected and are providing protection outside representative patch repairs when they are installed. For National Highways, the use of the technology does not place any additional monitoring or maintenance requirements on the repaired structure beyond that required by the standard two yearly General, and six yearly Principal, Inspections.

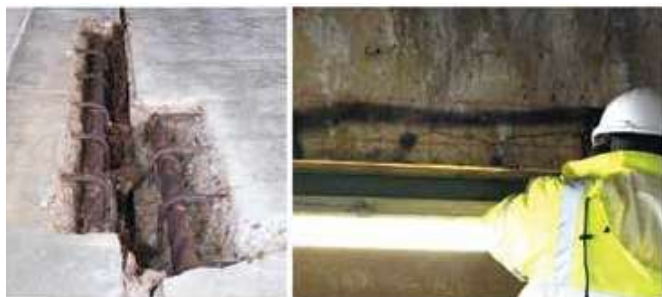
Figure 4: Examples of Corrosion Damage Observed During the Repair of the Car Park in 2010 and 2011.

Grosvenor car park was constructed around 1975. By 2010 it had suffered extensive corrosion damage to the decks due to chloride contamination from de-icing salts (Figure 4).

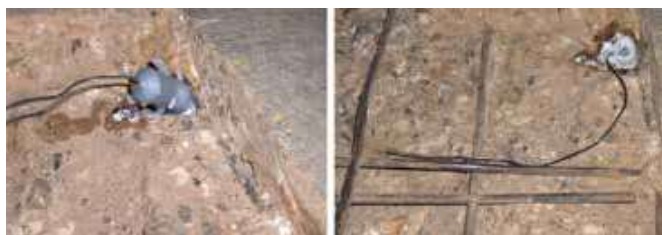
Figure 5: Installation of Anode in Parent Concrete at Repair Edge and its Connection to the Steel in 2010.

The solution for the Grosvenor car park included the use of galvanic anodes installed in drilled holes at the edge of the concrete repair. The anodes were connected to the steel exposed in the repair using a connector of the anode assembly (Figure 5). The application of a high-quality repair mortar completed the repair process [11]. To reduce complexity, there was no facility to disconnect the anodes or measure current output. The commissioning process for galvanic anodes was in its early stages of evolution at this point in time.

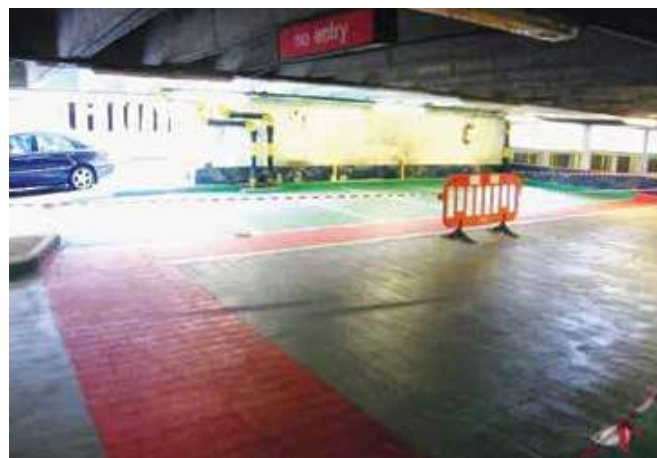
Figure 7: Coating or Membrane Applied to the Decks of The Grosvenor Car Park in 2011.

The polarisation effect was monitored for 215 days at various locations throughout the car park. The distance of the effect ranged between 500 and 750 mm from the edge of the repairs [11]. After this time the deck was coated with a trafficable waterproofing membrane and was no longer accessible for potential mapping (Figure 7).

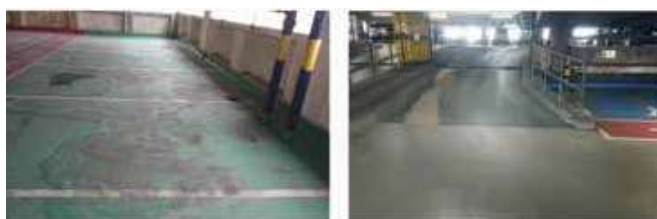
Figure 8: Evidence of Poor Drainage (Left), Membrane Wear (Right) Observed in 2023.

In 2023, more than 12 years after the installation of the anodes, a visual inspection of the car park was undertaken. There was substantial evidence of ponding water and some evidence of coating wear, but no evidence of further corrosion-induced damage was visible. Examples showing the condition of the car park are provided in Figures 8.

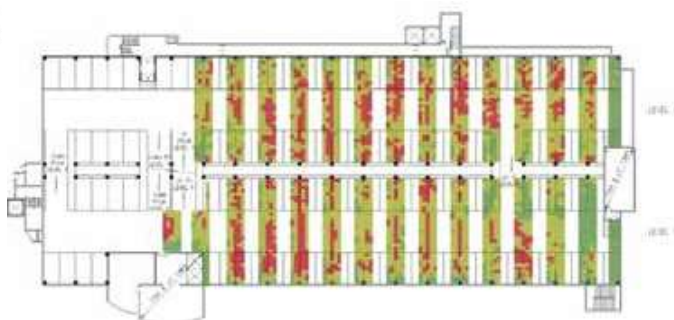
Figure 9: Pre-Installation Steel Potential Survey with ASTM C876 Colour Coded Corrosion Risk Bands.

Thirty reference zones were installed across the 5 decks. The locations were chosen as a representative sample of the protected area and included many of the most negative potentials found during the potential mapping of the structure prior to repair. A sample of the potential map can be seen in Figure 9, with the red colour indicating the highest corrosion risk zones along beam lines [12].

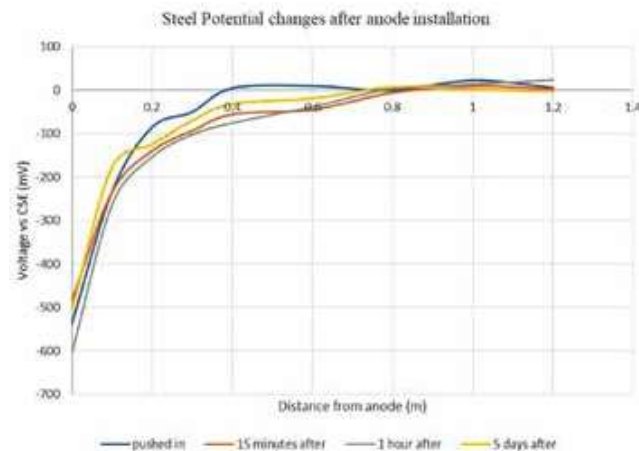
Figure 10: Relative Steel Potential Data Taken From a Single Anode Installed on the Car Park Deck Over a 5 Day Period.

During the initial installation, the effect of the anode on the local steel potential was measured at 50 mm intervals away from an installed anode as shown in Figure 10. The mixed potential of the anode and the steel indicated the ability of a single anode, installed in a drilled hole away from the steel, to protect reinforcement at a distance of around 600 mm from the anode. Galvanic anodes are often installed in a grid configuration, in which case the steel within the grid will typically be polarized by the overlapping effect of four anodes, not just one, significantly increasing the degree of protection.

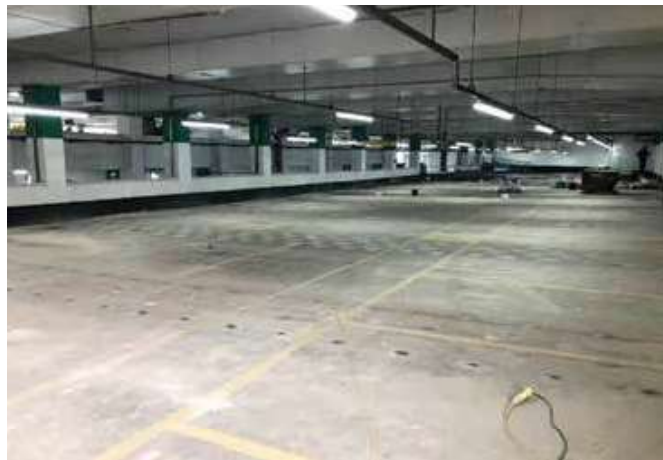
Figure 11: Car Park Deck Photo Taken After Installation of Anodes Before the Application of Deck Coatings.

The anodes at Prince Bishop car park were installed in 4 staggered rows across the deck, 2 rows directly above the beams and 1 row on either side of the beam as seen in Figure 11. All four of these rows formed one zone, connected by insulated titanium wires to two steel connections in the deck or via a junction box mounted in discrete locations. Data was accessible in the zones where reference electrodes were connected to the junction boxes. After anode installation, the deck was coated with a trafficable protective membrane to prevent further water ingress.

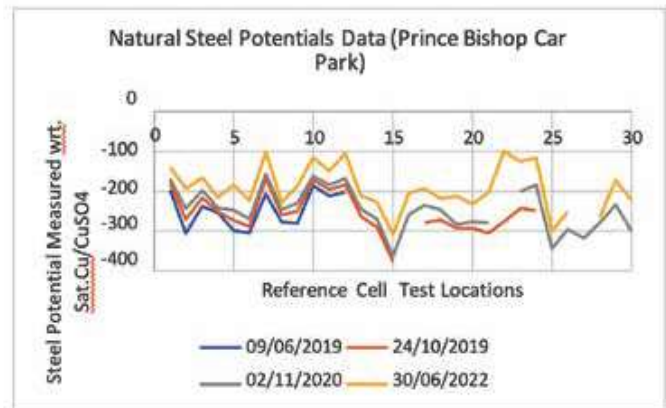
Figure 12: Steel Potentials Measured Over a 4 Year Period After installation of a Purely Galvanic Corrosion Management System.

During the first 4 years of service, the natural steel potentials were found to have trended much more positively in all test zones by an average of 76.6 mV, indicating the steel is becoming more passive, as shown in Figure 12 (below). Corrosion rates in June 2023, calculated using the Butler-Volmer Equation, were found to be between 0.03 and 0.86 mA/m²; significantly below the 2 mA/m² threshold for negligible corrosion, and a visual inspection indicated no visible signs of corrosion.

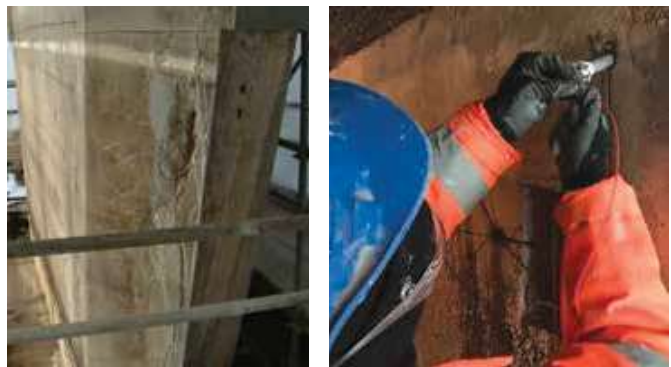
Figure 13. Example of the Damage (Left) and Repair Using Anodes (Right) on the Bridge Piers in 2007.

By February 2007, the piers of Whiteadder Bridge, near Berwick-upon-Tweed in Northumberland, had suffered extensive visible cracking and delamination of the concrete cover. Chloride contamination was high at up to 1.68% by weight of cement, and the piers were subject to extreme wet-dry cycling due to frequent flooding of the River Tweed. The damage is illustrated in Figure 13.

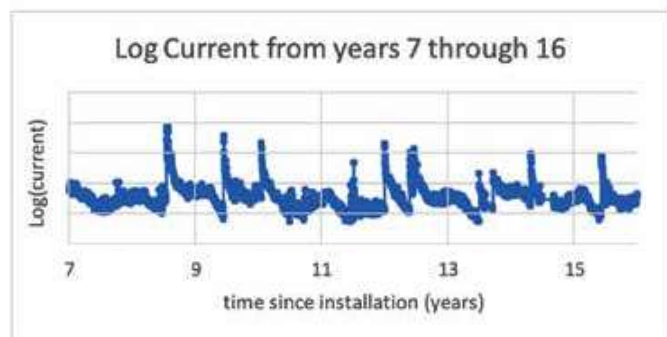
Figure 15: Trend in Current Output Over the Last 9 Years.

Though the initial current from the anodes was high, in part a design feature of the anode type used, the long-term data shows the anodes achieving a steady state. The trend in current is provided on a logarithmic scale from years 7 to 16 in Figure 15 below. The current trend has not substantially changed over this period, with the average current responsive but relatively stable over the 9-year period. The biggest effect on current is the flood events, which give rise to an order of magnitude increase, peaking at over 6 mA/m² of current density. Smaller increases are observed cyclically due to temperature fluctuations.

It is highly significant that the long-term data shows the trend in current stabilising after the initial period of operation. A predictive model extrapolating short term data from the initial period of operation could lead to a false conclusion that current would continue to fall and that the system would become ineffective within 10 years [16,17]. However, in reality, the anodes are continuing to deliver protection in response to corrosion risk, and the structure is showing no signs of corrosion distress as shown in Figure 16.

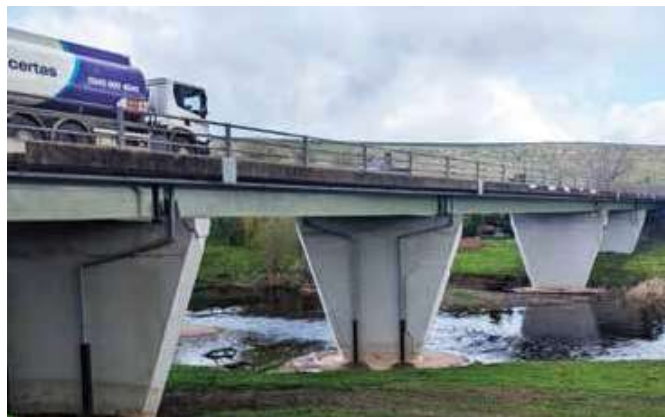
Figure 16. Whiteadder Bridge in March 2023.
