Independent Hybrid Corrosion Protection Appraisal

On behalf of:
Concrete Preservation Technologies Ltd.

DuoGuard™ Hybrid Anode™ Site Performance Review

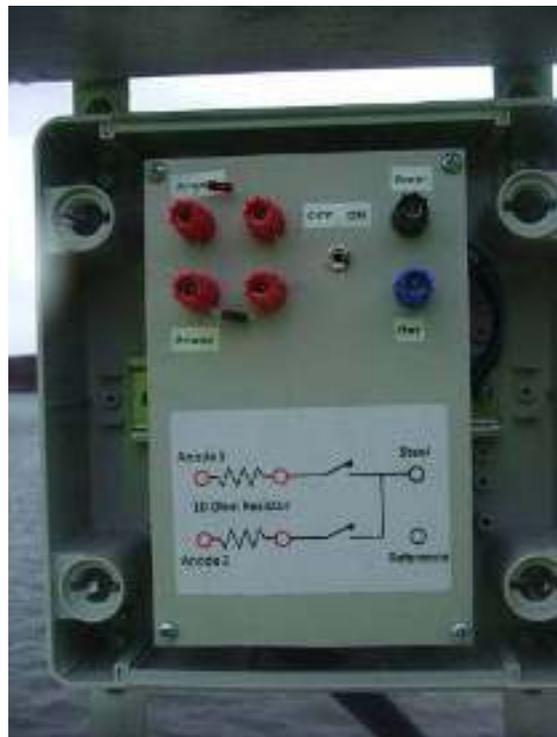
Figure 6 - General view of permanent monitoring location at parapet level

To regulate the current output of the hybrid anodes a specially designed voltage and current controller was installed during the temporary impressed current phase along with permanent MN15 reference electrodes to monitor steel potentials. Permanent junction boxes were installed at parapet level to allow manual monitoring (Figure 6).

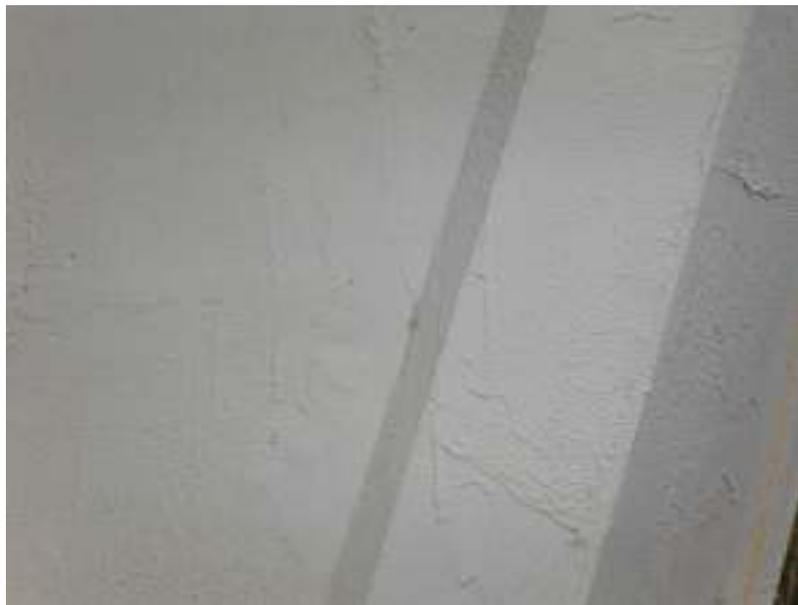
Figure 9 - Waterproof surface coating to all reinforced concrete piers

The reinforced concrete piers were found to be in generally good condition but with some water ingress defects observed. A significant amount of water and rust staining was noted on the piers however it is believed that this arises from the primary steel girders when water ingress occurs through the deck joints or through a fault in the drainage system. The extent of water and rust staining at high levels of the reinforced concrete piers can be seen in Figure 11. On closer inspection, evidence of corrosion of the steel girders was observed near to the location of all bridge joints suggesting that they are now failing to prevent water and chloride ingress from the above carriageway (Figure 12). The ingress of water and possible chlorides to the reinforced concrete will be significantly reduced by the applied waterproof coating on the piers.

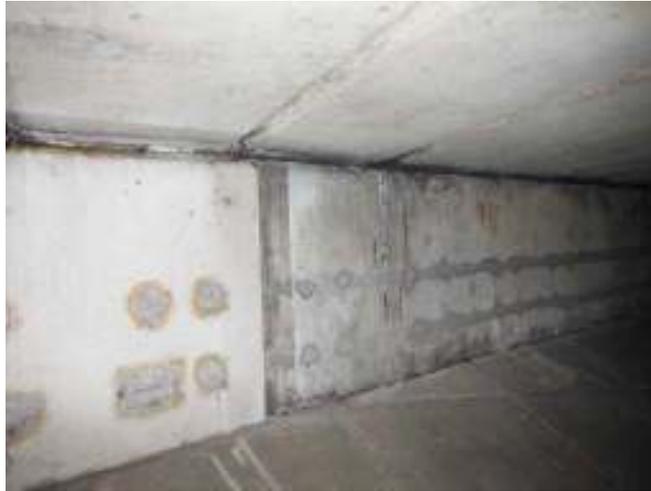
Figure 15 - Waterproof coating to South abutment

Concrete repairs were made to areas of significant corrosion damage. DuoGuard™ 500 anodes were installed at 400-500mm spacings in the reinforced concrete abutments and piers where significant levels of chloride content were found. The design life of the system was 30 years and was based on steel densities of 4.09m² and 1.17m² per metre squared of concrete for the pier beams and columns respectively. Reference electrodes and data logging equipment were installed on the bridge to allow remote monitoring of the structure. The reinforced concrete abutments and piers had an additional waterproof coating applied. It should be noted that the waterproof coating was only applied to one sixth of the South abutment (Figure 15).

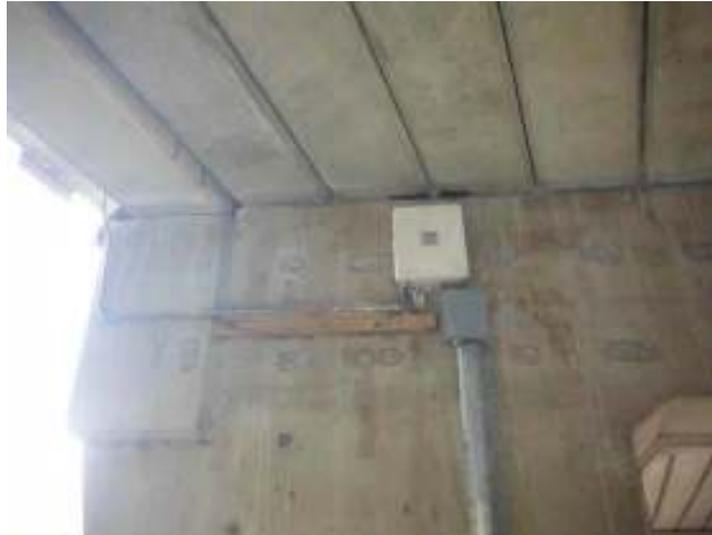
Figure 17 - Monitoring equipment and steel conduit, South pier, verge facing

The enclosure for the data logging equipment was found to be in good condition (Figure 17). Minor cracking was observed in the waterproof coating in a number of locations; however the depth of the crack could not be confirmed. Only one defect which was outside the area of influence of the hybrid CP system was identified during the hammer tap survey covering an area of approximately 1000 x 400mm. It is a possibility that the defect may be due to a debonding of the waterproof coating as other minor surface coating defects were also observed during the inspection (Figure 18). Alternatively it may be due to delamination of the concrete surface as there is a small possibility that the adjacent anode zone has been disconnected.

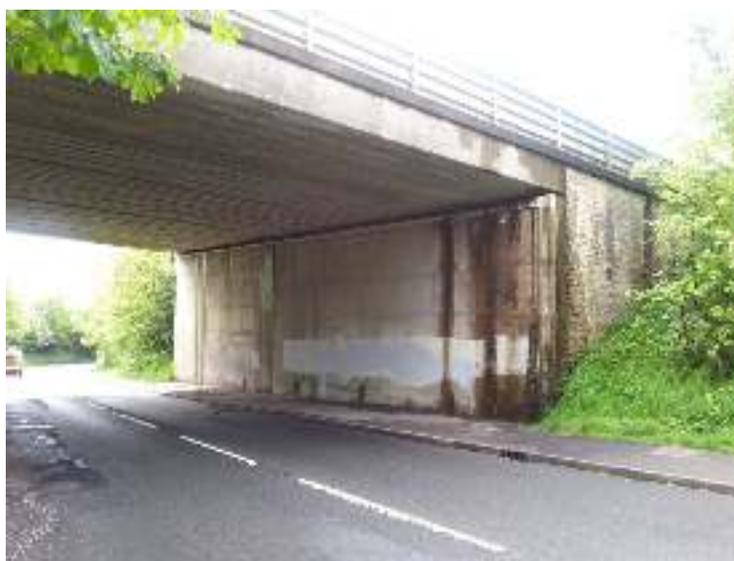
Figure 22 - Storth Lane South abutment (North facing)

A visual inspection of the reinforced concrete abutments was conducted from ground level on 23rd May 2014. On the day of inspection it was noted that significantly more water ingress was observed on the South abutment compared to the North abutment (Figures 22 and 23 respectively).
