Milford Bridge

Derby, UK

Structure: Milford Bridge

PatchGuard™ Galvanic Anode System

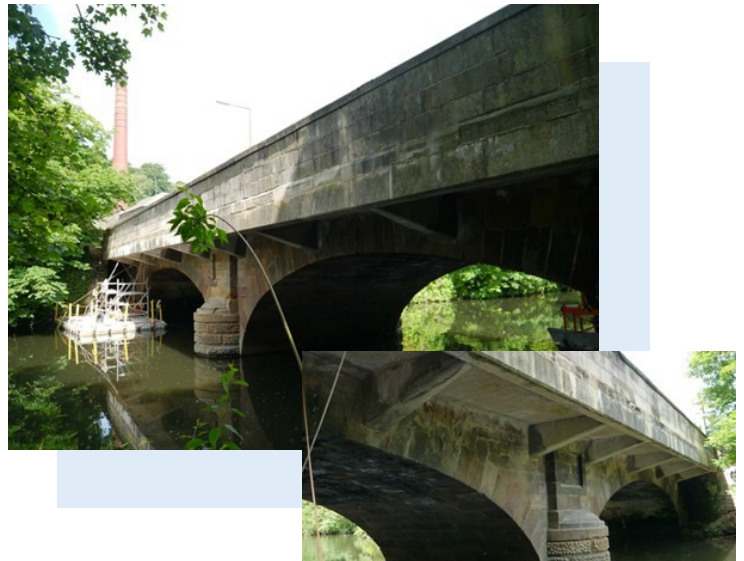
The Road bridge carries the A6 over the river Derwent in Milford, Derbyshire. It is comprised of a two-span masonry Arch bridge which has been extended at either side by reinforced concrete cantilevers/slabs to provide a pedestrian Footpath (1980's).

Poor drainage through the installed system and leakage at the joint between the new and old bridge had led to chloride ingress from the road above which had then led to significant damage on the cantilever sections and the deck soffit.

Following the removal of damaged concrete, 300 PatchGuard anodes were applied to the cantilever sections and drain outlets of the new bridge, after which the repairs were reinstated using repair mortar.

150 Patchguard Plus Connect anodes were installed in the soffit of deck slab along the junction of the new and old bridge to protect against the risk of future corrosion.
