# Cape Don Lighthouse

**Structure:** Cape Don Lighthouse

DuoGuard™ Hybrid Anode™ System

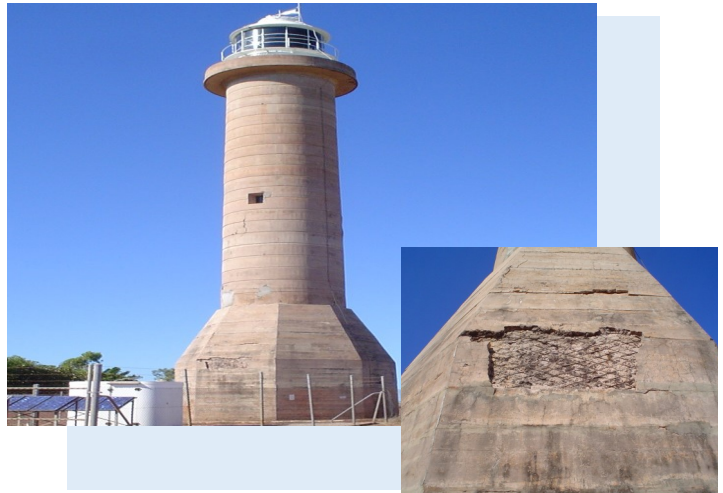
*The Cape Don Lighthouse is located on the western side of the Cobourg Peninsula , Northern Territory , Australia. The Lighthouse was built in 1917 to mark the eastern approach to Darwin (the passage between the Cobourg Peninsula and Melville Island) .*

Over the last 20 Years the condition of the structure had deteriorated and it was suffering from concrete reinforcement corrosion. This was believed to be the main contributing factor to the spalling **and** delamination seen.

The DuoGuard Hybrid Anode system (4500 DuoGuard 175 & 500 Anodes) was installed to halt ongoing corrosion risk. Due to the tropical environmental conditions and transportation of materials via barge ex Darwin the project was extremely challenging.

The corrosion protection system was designed to ensure an extended 25 years of jetty service. MN15 reference electrodes were also installed for continuous monitoring of the system , with the facility to determine steel corrosion rates.
