## The Problem Identified

Sherbourne Bridge anode installation

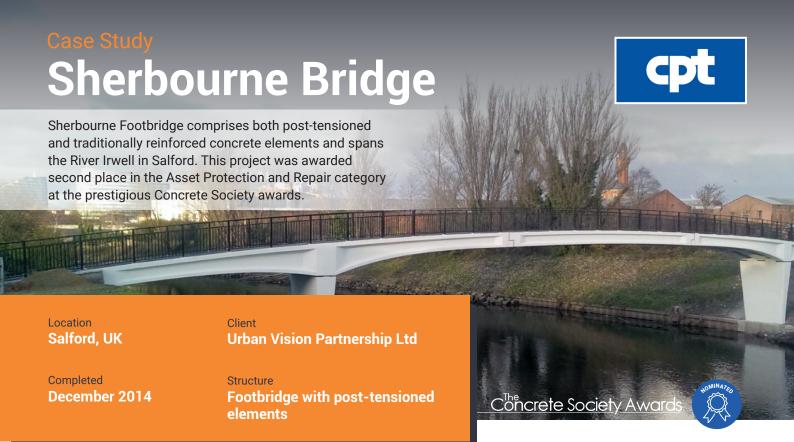
Extensive testing of the post-tensioned beams and conventionally reinforced pier structures was carried out. Chloride profiling, carbonation depth analysis and half-cell potential mapping, revealed significant corrosion damage and areas at high risk of future deterioration. Particular care was required to avoid any damage to post tensioning tendons during either investigation or treatment works.

CPT designed a DuoGuard™ hybrid anode system to halt ongoing corrosion and prevent further damage to the footbridge. Using an external power source, an impressed current was applied to stop active corrosion and render the steel passive. The DuoGuard anodes were then disconnected from the power source to self-generate a galvanic current, sufficient to maintain steel passivity and control corrosion. Due to the possibility of hydrogen embrittlement of the tendons, the impressed current phase of the hybrid treatment was closely monitored and controlled.

CPT also supplied a bespoke monitoring system, allowing the performance of the corrosion control system to all twelve beams to be individually checked and supervised.

In addition, concrete repairs and anti-carbonation coating works were carried out in accordance with BS EN1504.
