## Case Study

# Shelbourne Hotel Dublin

Structure  
**Heritage Building (Hotel)**

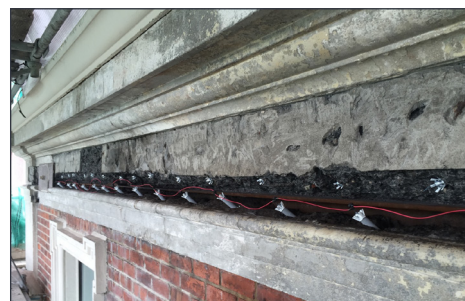
Shelbourne install

Testing found that all corrosion rates were above the threshold for passive steel. In addition, the fully carbonated concrete was providing no protection against corrosion. A DuoGuard™ hybrid anode system was designed to halt the ongoing corrosion and prevent future damage. Using an external power source, an impressed current was applied to stop active corrosion and render the steel passive. The DuoGuard anodes were then disconnected from the power source to self-generate a galvanic current, sufficient to maintain steel passivity and control corrosion.

A trial was done before the full system installation to ensure compatibility with the clinker/steelwork arrangement and to collect on-site data to aid design. During the impressed current phase, the clinker concrete let current freely pass between the anode and steel. In phase two the galvanic current output was effective at maintaining steel passivity at a spacing of 300mm between installed anodes.

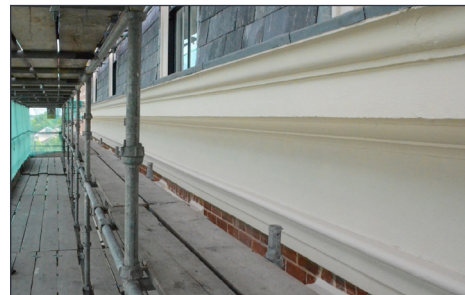
Shelbourne complete

Corrosion related deterioration of the Shelbourne Hotel was halted. After the initial power up period, the self-powered DuoGuard hybrid anodes minimise all future maintenance requirements and associated life costs.
