# Saints Peter Paul and Philomena Church

Location  
**New Brighton, Wirral Peninsula, UK**

Client  
**Lawrenson Associates**

Structure  
**Historic Building**

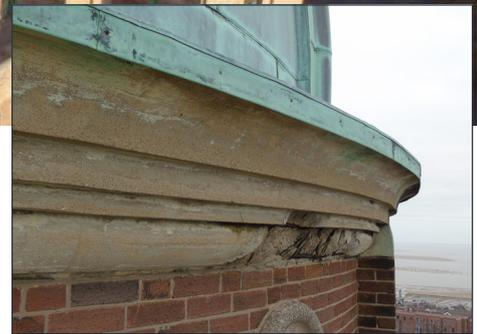
Exposed on all sides to a chloride rich environment, coastal chlorides had contaminated various reinforced concrete structural elements of the Church, including the dome ring beam. Expansive rebar corrosion had led to areas of cracking and spalling of the concrete cover.

The structural problem identified

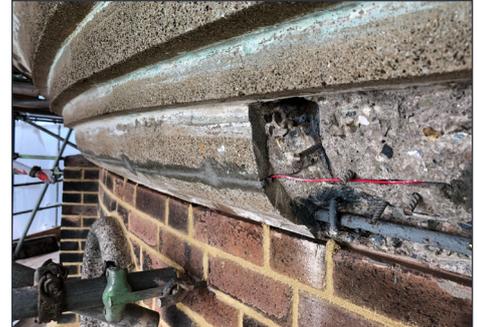
PatchGuard Connect Galvanic Anodes were installed at 400mm centres around the circumference of the ring beam. The zinc alloy anodes were embedded into 25mm diameter holes inside an activation mortar and wired together in strings of maximum 40.

The solution developed

The targeted galvanic anode system was designed to mitigate corrosion for up to 20 years. Because the ring beam was also protected by a fairing coat and a protective coating, subject to periodic maintenance of the coating, the anode system could well extend beyond two decades.
