# Laverock Hall Bridge

Location <b>Cramlington, UK</b>	Client <b>Northumberland City Council</b>
Completed <b>July 2006</b>	Structure <b>Dual Carriageway Overbridge</b>

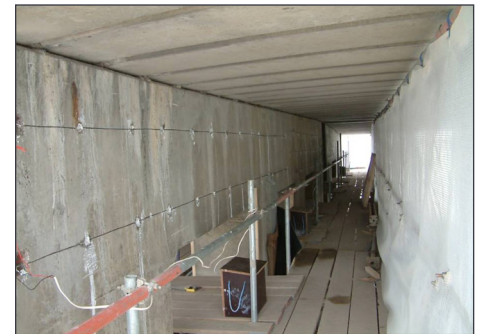
Temporary impressed current phase

Northumberland County Council were keen to have a low maintenance, long term solution to the reinforcement corrosion problems at Laverock Hall Bridge. A DuoGuard™ hybrid anode system was designed to halt ongoing corrosion and prevent further damage. Using an external power source, an impressed current was applied to stop active corrosion and render the steel passive. The DuoGuard 500 anodes were then disconnected from the power source to self-generate a galvanic current, sufficient to maintain steel passivity and control corrosion.

Monitoring equipment and measurement probes were installed in the treated zones to allow remote monitoring of system performance. Results obtained from the monitoring system have indicated a potential anode lifetime of 50+ years.
