Saints Peter Paul and Philomena Church

Location
New Brighton, Wirral Peninsula, UK

Structure
Historic Building

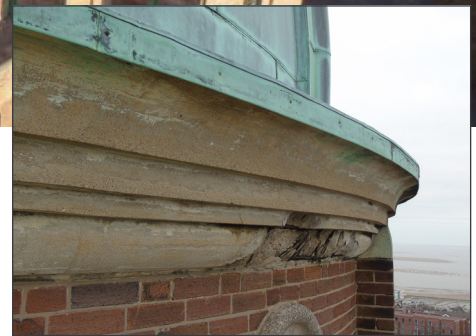
The structural problem identified

Exposed on all sides to a chloride rich environment, coastal chlorides had contaminated various reinforced concrete structural elements of the Church, including the dome ring beam. Expansive rebar corrosion had led to areas of cracking and spalling of the concrete cover.

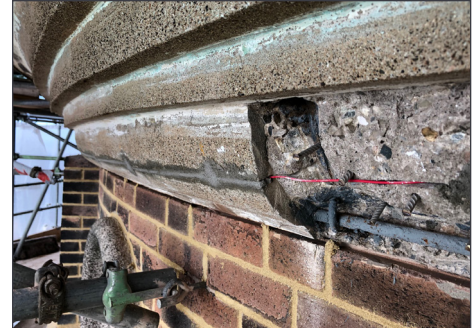
The solution developed

PatchGuard Connect Galvanic Anodes were installed at 400mm centres around the circumference of the ring beam. The zinc alloy anodes were embedded into 25mm diameter holes inside an activation mortar and wired together in strings of maximum 40.

The targeted galvanic anode system was designed to mitigate corrosion for up to 20 years. Because the ring beam was also protected by a fairing coat and a protective coating, subject to periodic maintenance of the coating, the anode system could well extend beyond two decades.

The sacrificial system offers long term corrosion protection to the reinforcing steel in the structure. The installed system will counter on-going corrosion and prevent concrete delamination.
