# Crossways Shopping Centre

Location  
**Subiaco,  
Western Australia**

Structure  
**Roof Top Concrete Carpark**

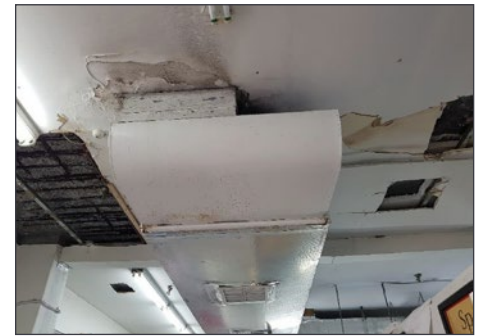
Crossways Shopping Centre is located close to a marine environment and the roof top position of the carpark means that it is particularly exposed to the elements. The decking was exhibiting the early signs of corrosion and insufficient reinforcement cover was indicated by surface cracking and delaminated/drummy sections.

Spalling to soffit below car park.

It was proposed that PatchGuard galvanic anodes should be positioned where the spalling was evident on the soffits of the shops below the carpark. As a precautionary measure anodes were also installed adjacent to patch repairs on the roof deck prior to the application of a trafficable membrane to the entire 2,500 square meters of the carpark decking.

Each PatchGuard anode was individually installed into the parent concrete and connected to the reinforcement. The system provides enhanced current distribution to the areas of steel at risk of corrosion and allows the use of bonding primers and either high or low resistive mortars within the patch repair. The system is designed to prevent the effects of the incipient corrosion effect adjacent to patch repairs. An additional coating was applied to provide further protection from the elements and provide an aesthetic appeal.
