# DUNDEE, BELL STREET

## CASE STUDY

Location  
**Dundee**

Structure  
**Car Park**

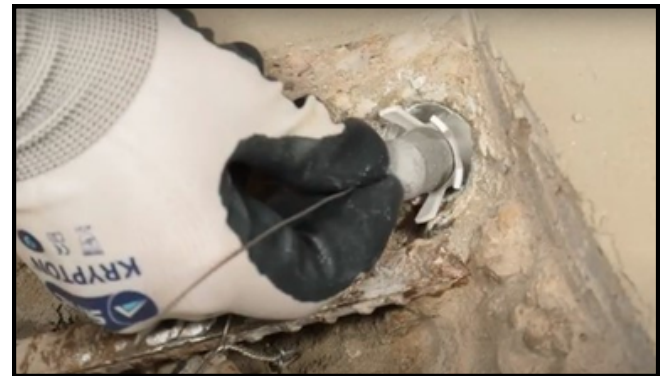
Bell Street Car Park is a multi storey reinforced concrete structure located in the heart of Dundee. Over time, the structure experienced progressive deterioration caused by chloride induced corrosion of the embedded steel reinforcement, resulting in widespread damage to the reinforced concrete elements.

Extensive structural refurbishment works were required throughout the structure, including more than 3,700 localised concrete repairs to decks, soffits, walls, columns, façade elements, and bridge sections, many of which required specialist access via MEWPs.
